TOTAL BUILDING
Engineering
S o l u t i o n s

Company Introduction

TBE Solutions Pty Ltd

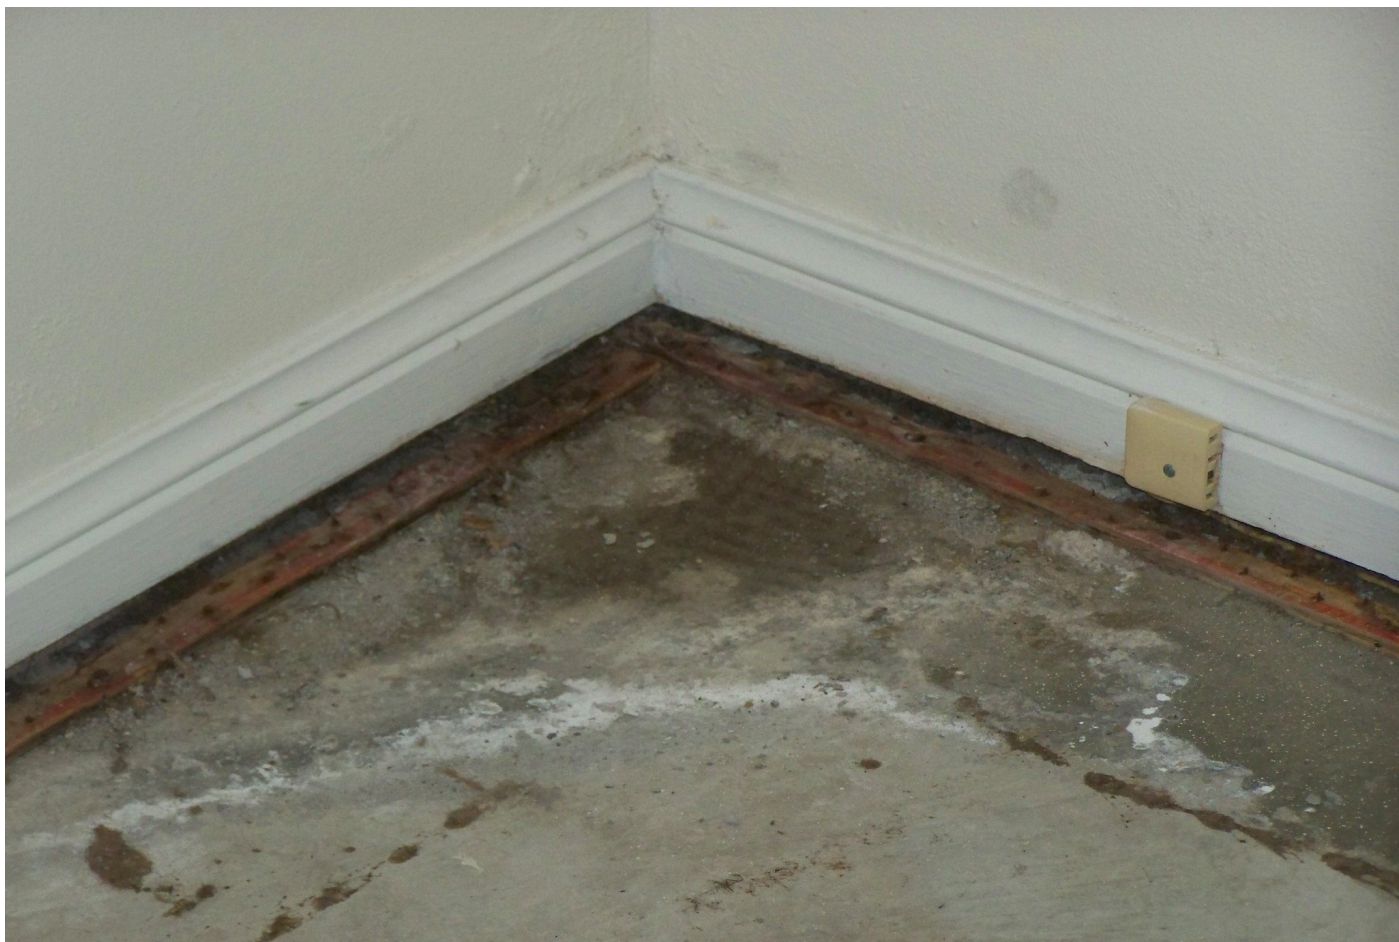
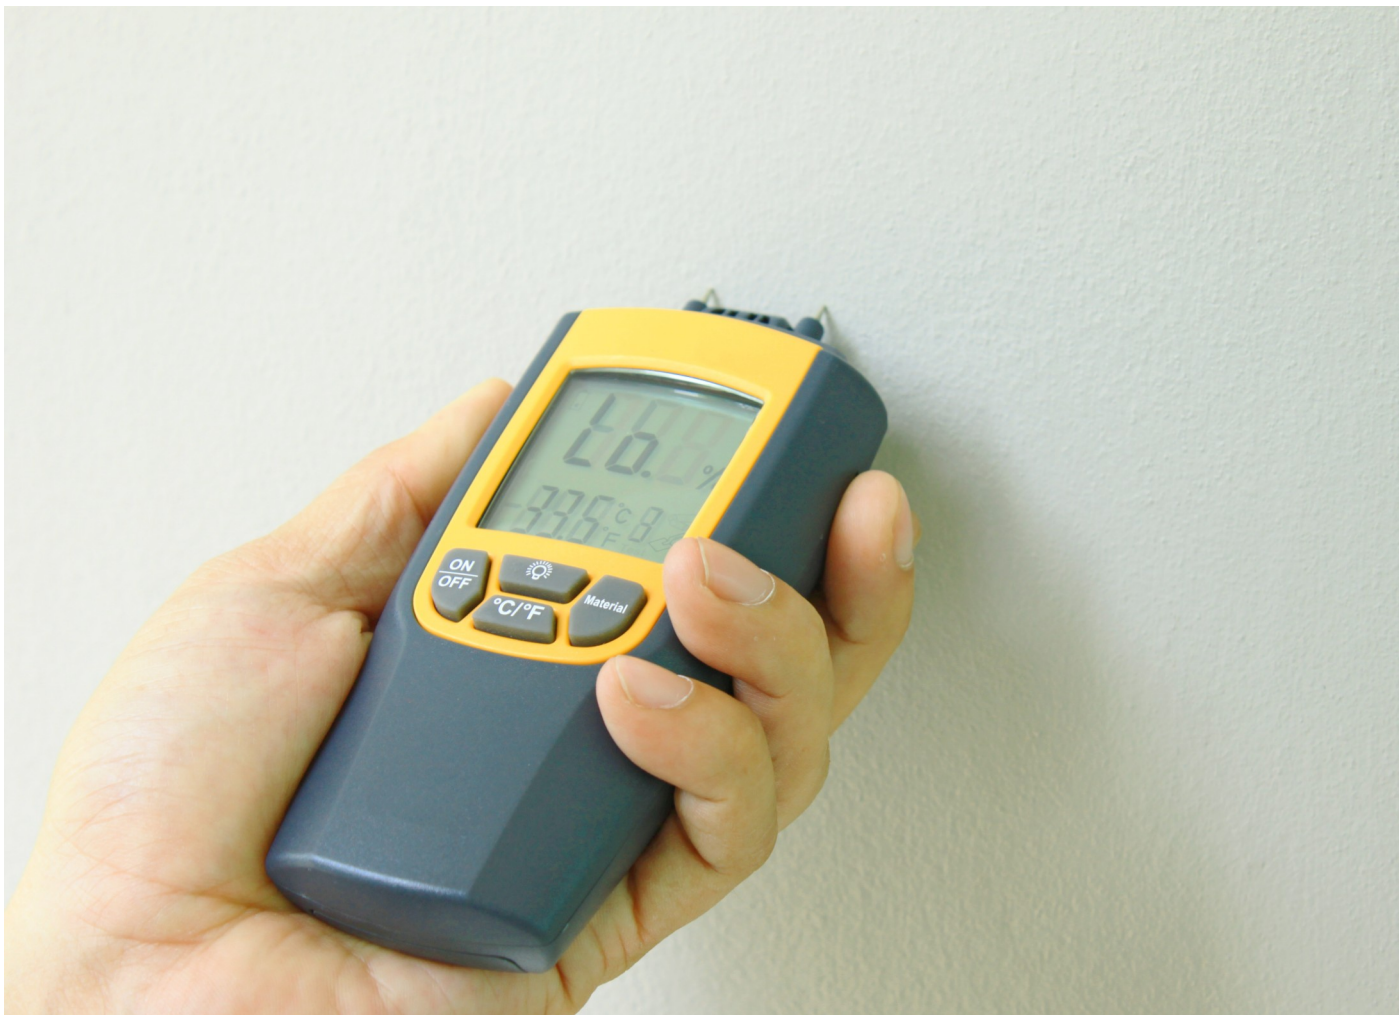
Moisture ingress is when water penetrates a product and it can be a factor, cause or significant contributor in nearly all of the building defects which will be examined in this section. When water gets into a product, its structural integrity is at risk because many ingredients in building materials can loosen in water.

To determine moisture ingress in a specific area, TBE Solutions Inspectors use a moisture meter (see image to left) which measures the percentage of water in a given substance. The tested area is usually considered fine if the reading is less than 10%, however anything above this percentage is usually indicative of water ingress.

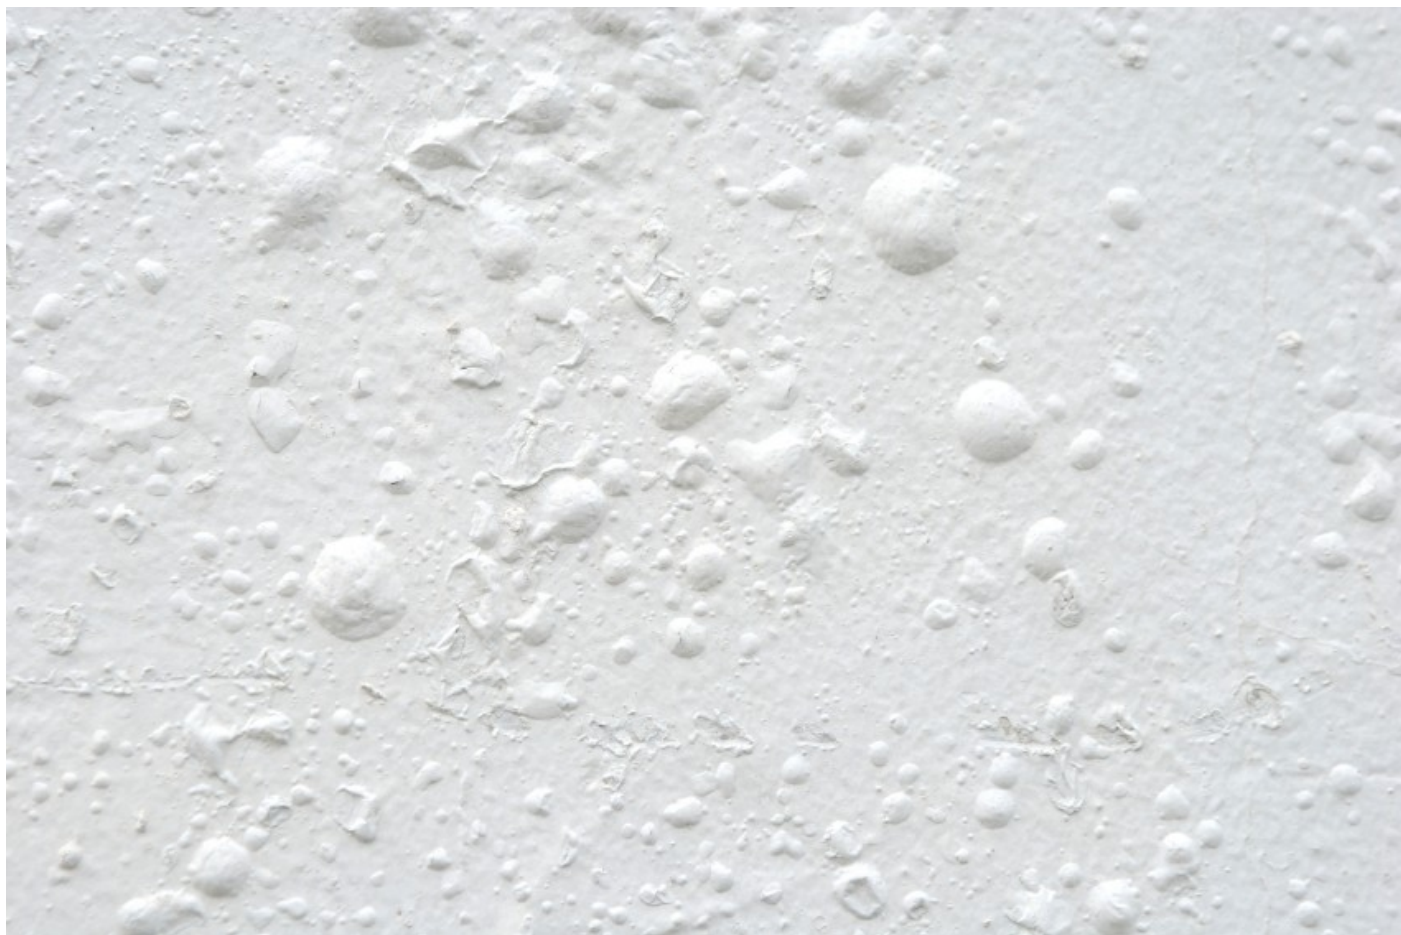
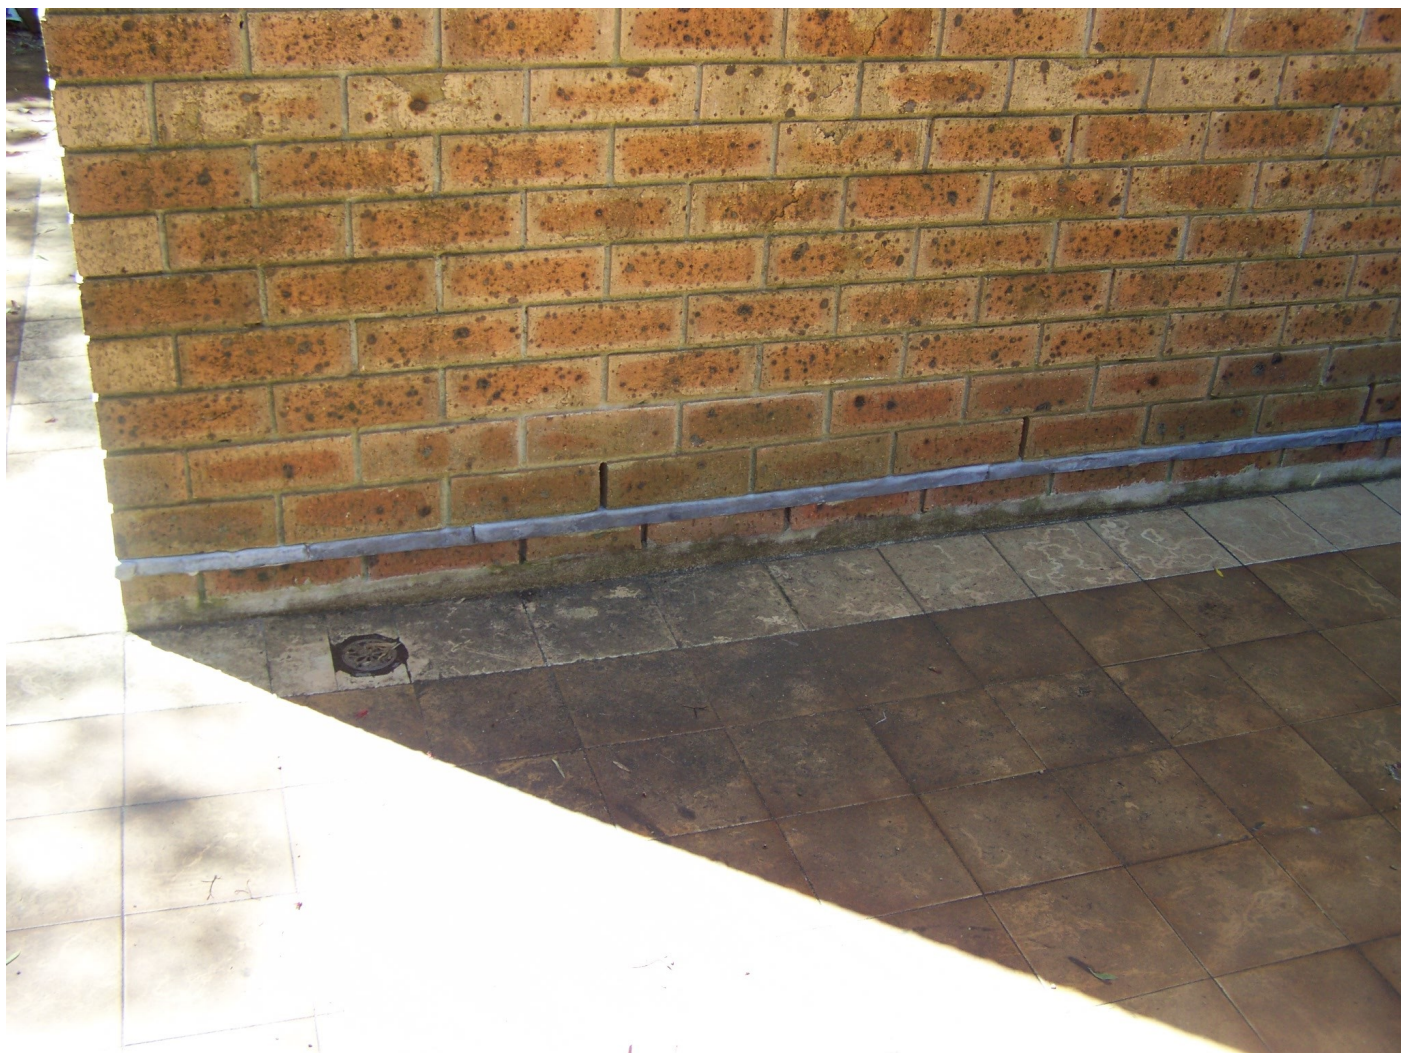
This is a sign of water ingress and it means the moisture has travelled from one side of the substrate (usually brick) through to the other side of the render which absorbs the moisture like a sponge — this causes the bubbling. This often happens on the other side of a wall which backs onto a bathroom or shower, and on the outside of a building where the moisture in the soil makes its way into the outer walls causing bubbling there. This is often also called “rising damp”, which is when the ground moisture containing salts rises up through the masonry or brick wall through capillary action and absorbs into the render which can cause bubbling.

Slab edge dampness is as simple as it sounds: it is when a concrete slab edge becomes damp. Most slab edges are occasionally damp due to rain, garden watering, or by contact with the ground. In some cases, when this dampness is able to permeate from the outside to the inside it can affect the internal walls and/or finishes of a building. Indications of slab edge dampness include persistent dampness of the exposed face of the concrete slab/footing, efflorescence (see p. 23), drummy render (see p. 21), pungent odours in floor coverings (ie. damp carpets), watermarks, mould growth (see p. 17), rusting and external paint blistering/peeling/bubbling. All aspects of planning, site excavation, construction and post-construction landscaping must be considered to minimise the risk of slab edge dampness and moisture ingress.

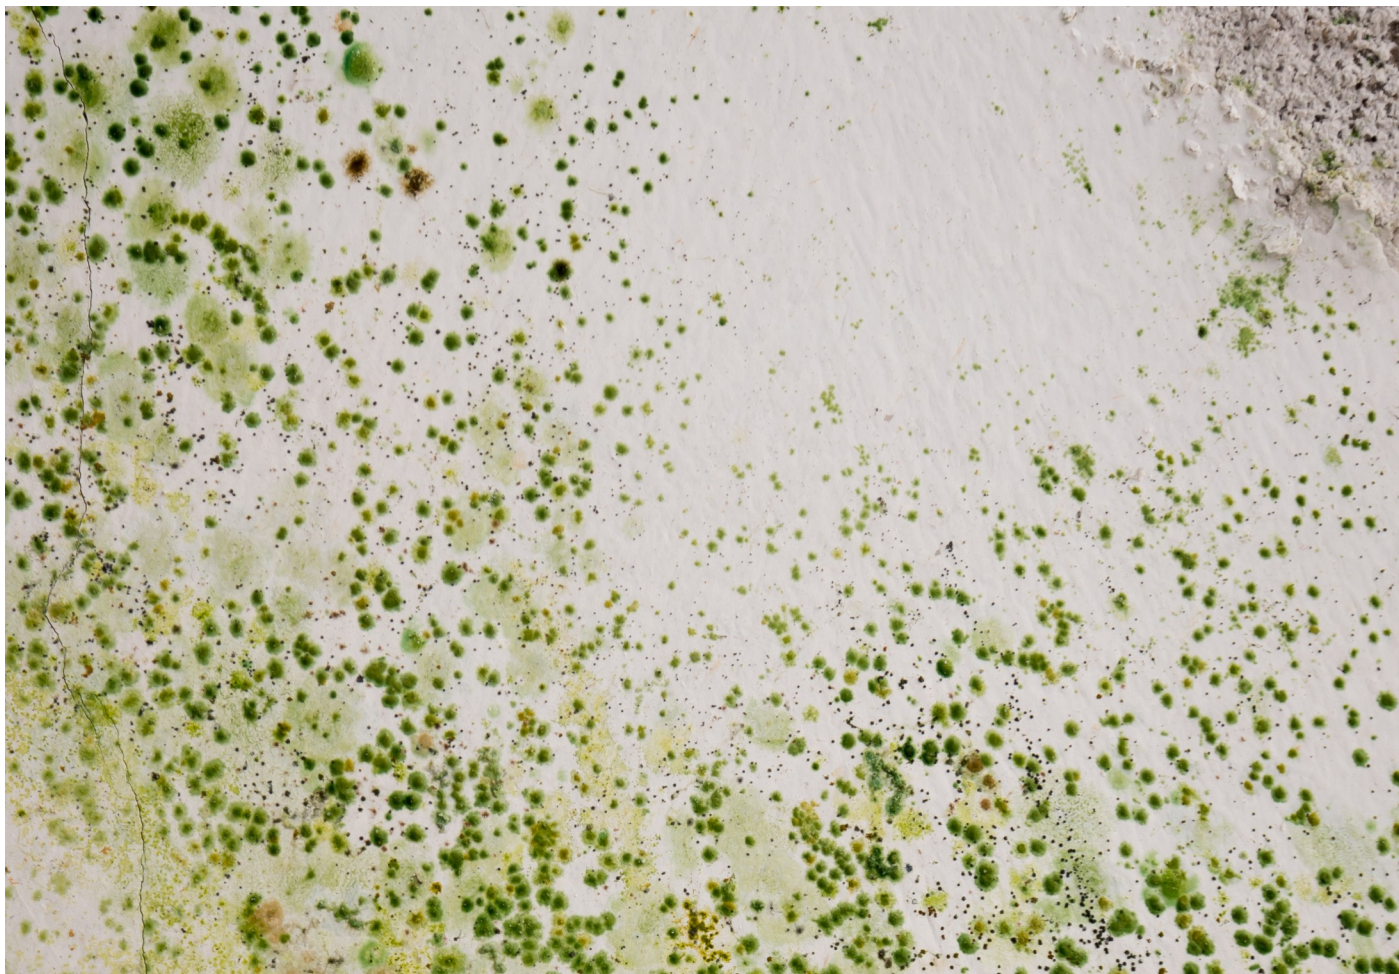
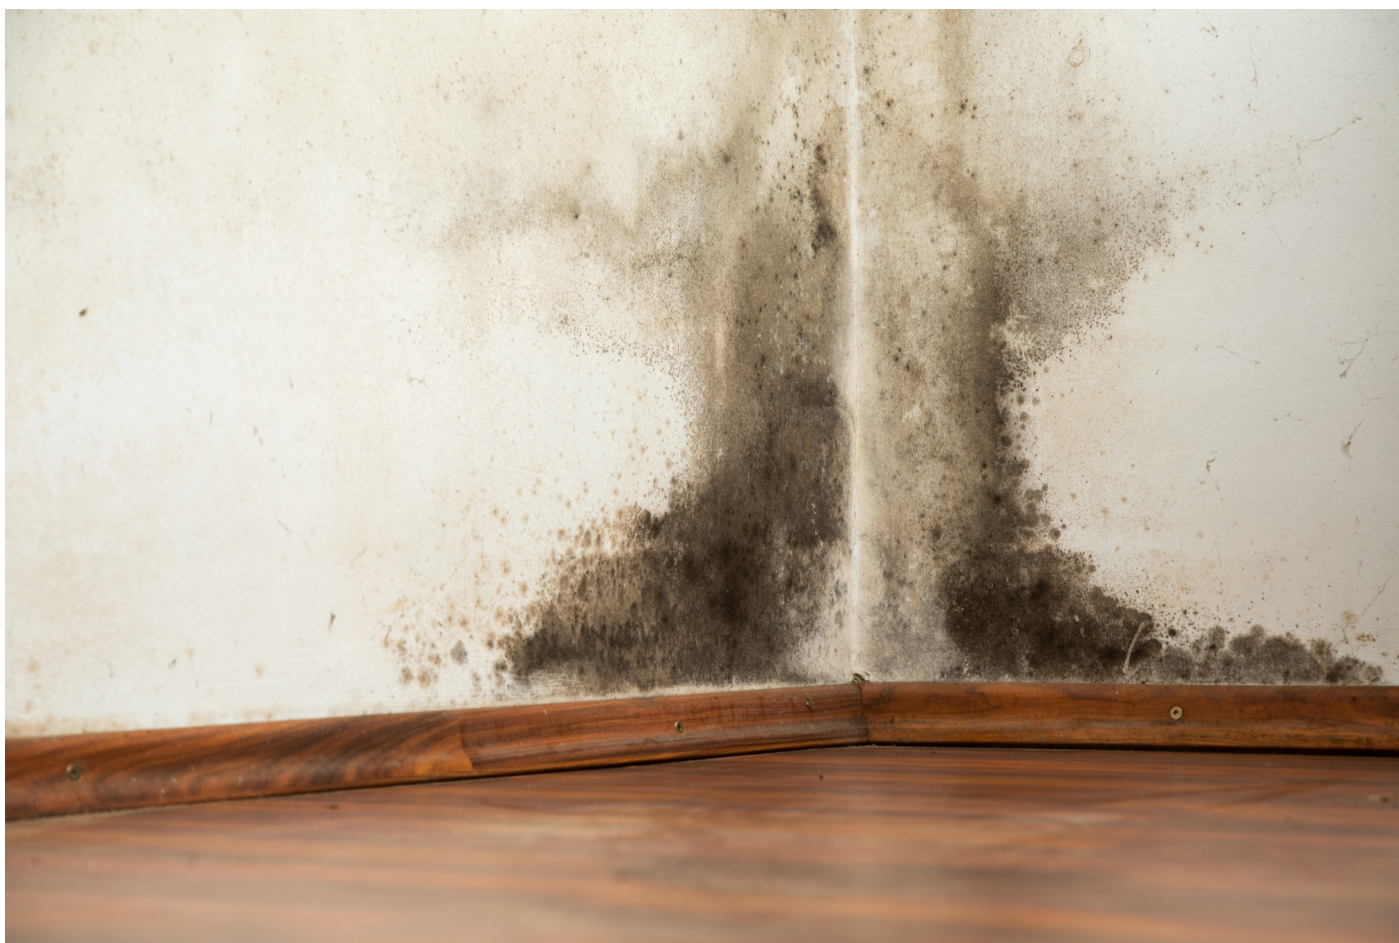
Moulds are found everywhere — both inside and outside, and they reproduce by spores which can be carried by air currents. There are only two conditions which must be met to allow their growth: the presence of nutrients and moisture. Because common building materials (such as drywall, carpets, and wood) provide the nutrients which moulds feed on, indoor mould growth is typically related to the introduction of water. Flooding, leaky roofs, building maintenance problems, or indoor plumbing problems can all lead to mould growth.

The presence of mould is only visible to the human eye when mould colonies grow. Mould can be present in spore form, invisible to the naked eye, or it can grow inside walls after a water damage incident and be dormant and concealed until the right conditions—such as high humidity—reactivate it. This is how mould often appears suddenly, and possibly long after an incident of water damage which did not seem to create a problem at the time.

The simplest way to counteract mould, then, is to reduce the moisture levels which facilitate its growth — allow air and sun to penetrate your building daily. Aeration, cleanliness and sunlight are the simplest ways to dry up water and reduce the stability of the temperature and humidity of the environment (as a stable environment is particularly attractive to moulds). If a building or area already has the presence of moisture and is left in the dark it is likely to produce mould.

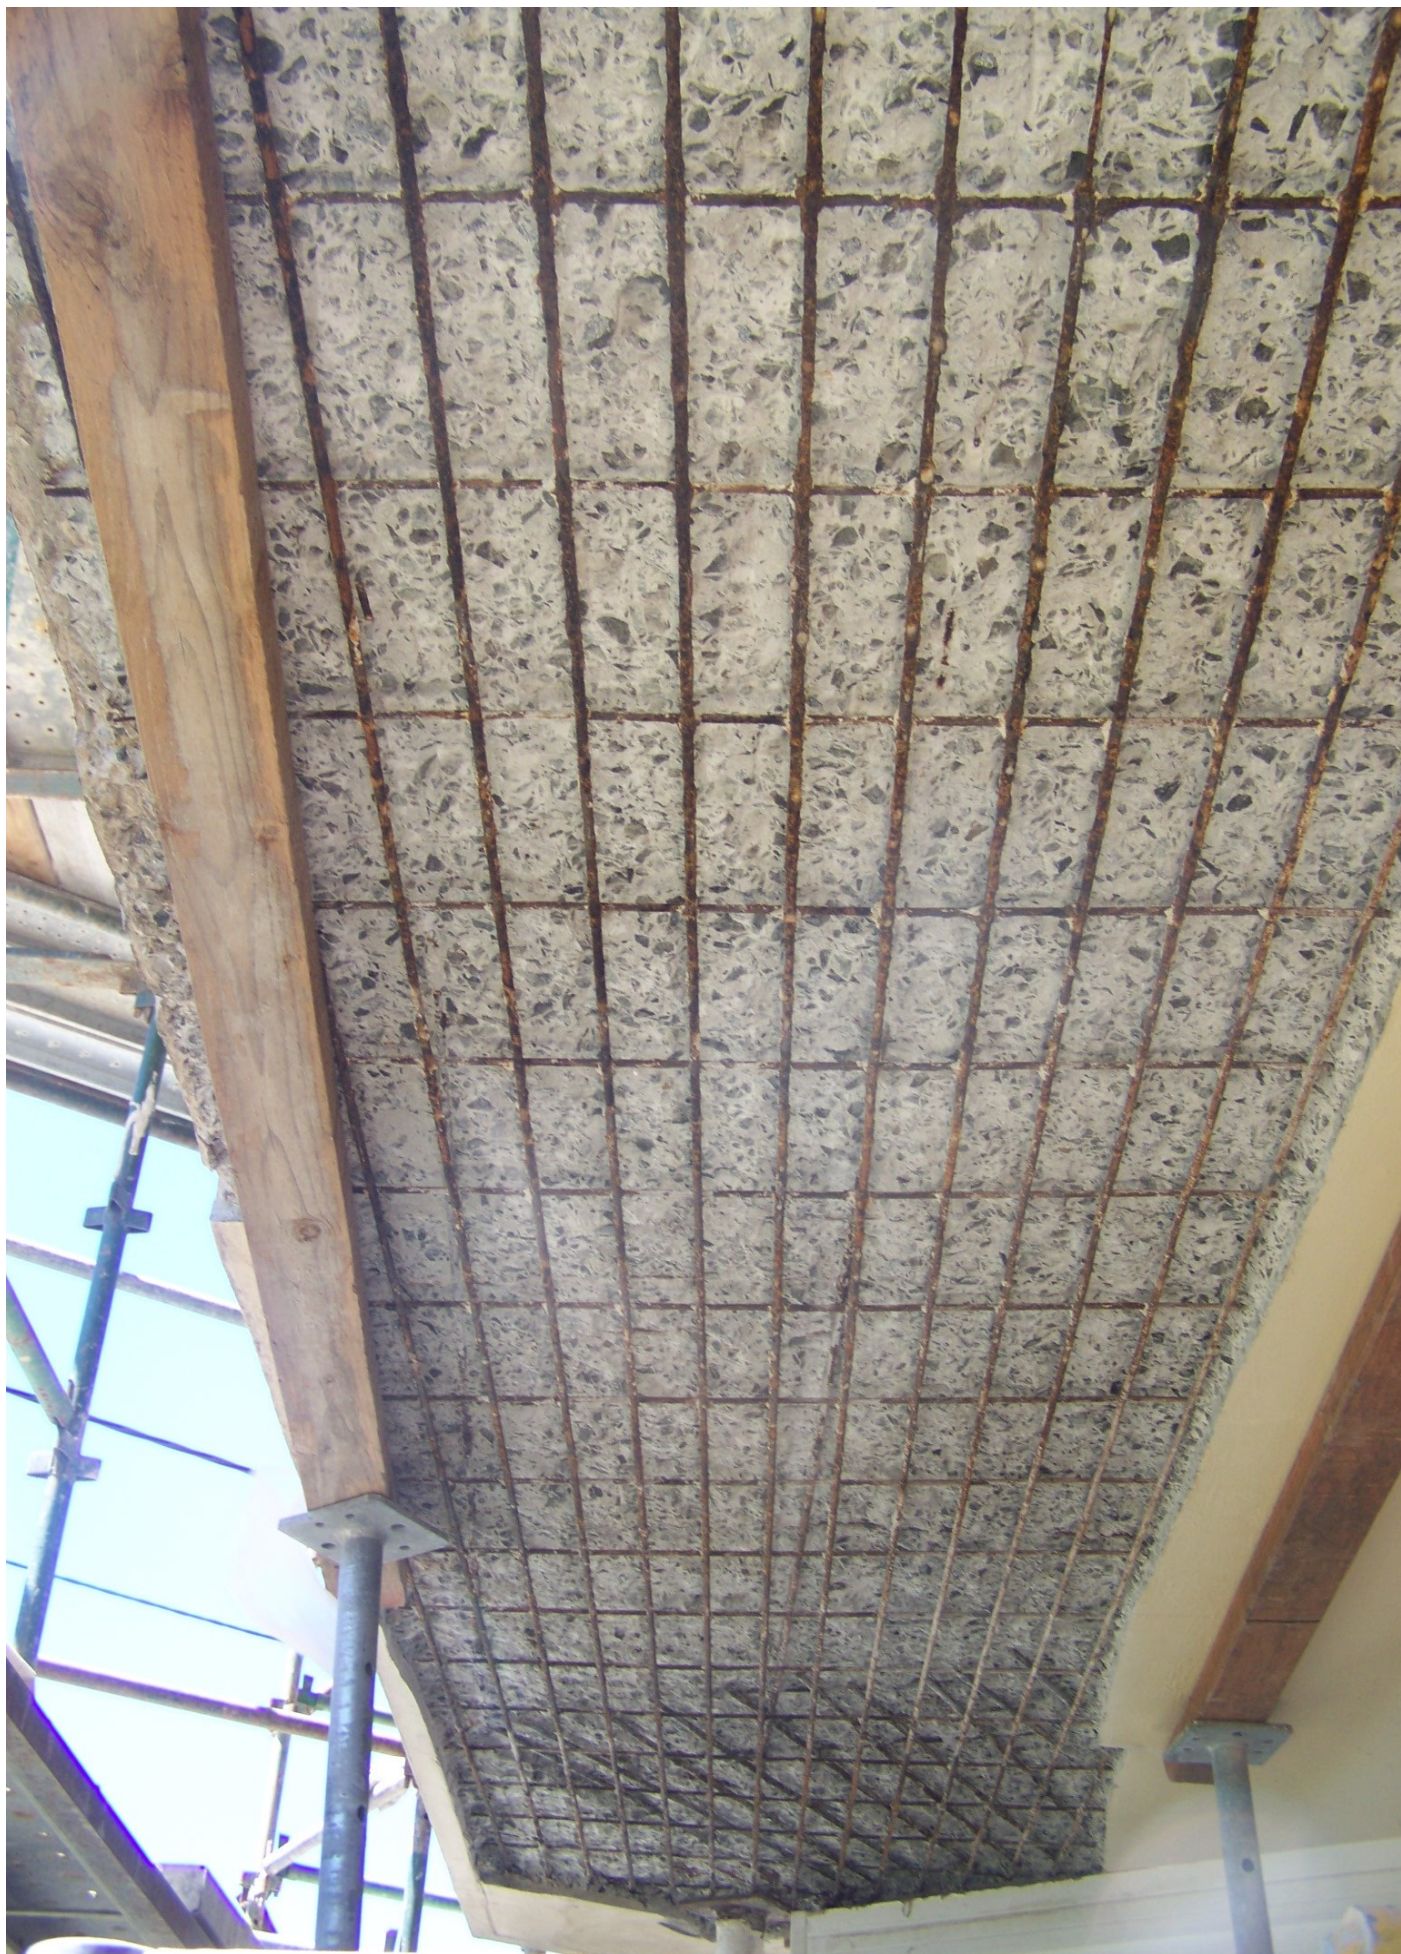
When concrete is used in construction, steel bars or steel mesh is often used as reinforcement. But when exposed to air or water, steel can corrode, which causes it to expand and often cracks the concrete it is in. It is also called “concrete cancer” due to the progression of the corrosion. Once the concrete has cracked, it further exposes the steel to water and air, speeding up the erosion of the reinforcement.

The cracking or breaking down of concrete due to the corrosion and expansion of the inner steel reinforcements.

If the spalling has affected the integrity of the concrete, remedial action usually includes demolition of the entire affected section and rebuilding of the structure. If there are parts of the steel reinforcements that are unaffected, then only the affected parts (if more than approximately 20% corroded) need to be removed and replaced, but it will depend on the severity of the corrosion.

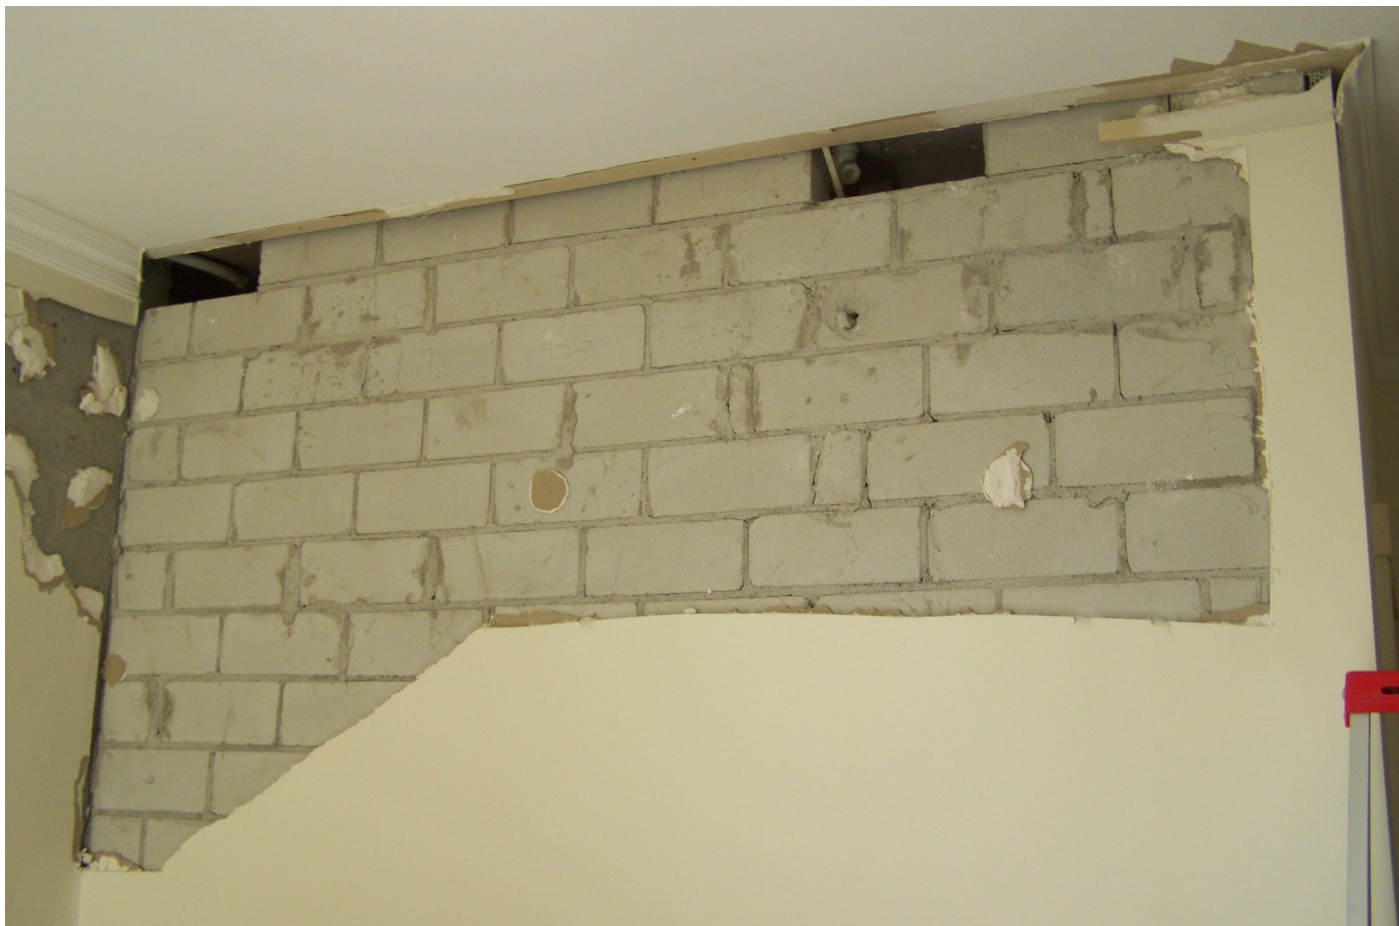
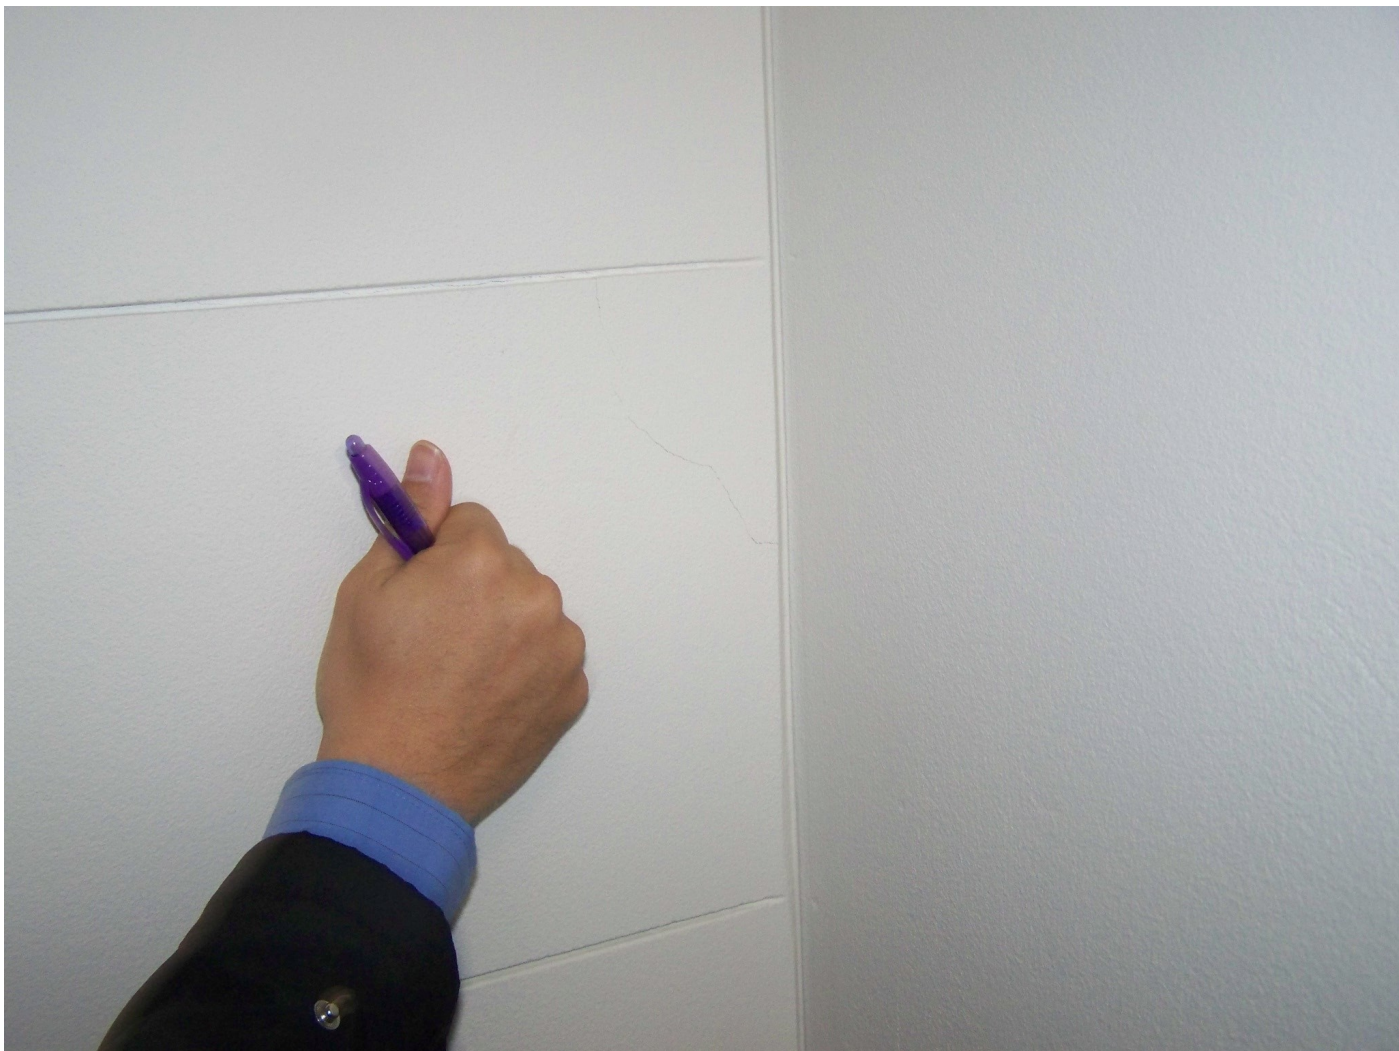
Drummy render is when the cement or plaster render coating becomes loose. When tapped with the plastic handle of a screwdriver, or sometimes just your knuckles, it produces a hollow, weak sound (ie. it sounds like a drum, or it sounds “drummy”).

Drummy tiling is caused when the adhesive bond between the tiles and the wall or floor breaks down. This can break down if water gets in behind the tiles. In modern homes with large tiled areas, drummy tiles often result from floor tiles being installed without expansion joints. As tiles expand with age, the stresses cause the adhesive to fail. Depending on how extensive the break-down is, the best solution is usually to totally re-tile the area.

Drummy render can be a dilemma — it could indicate cracking in the walls behind or may simply be due to slight movement and breaking of the bond to the brickwork. It may stay there for many years or fail within the hour. If you find you have drummy render the common solution is to remove the drummy section and re-render.

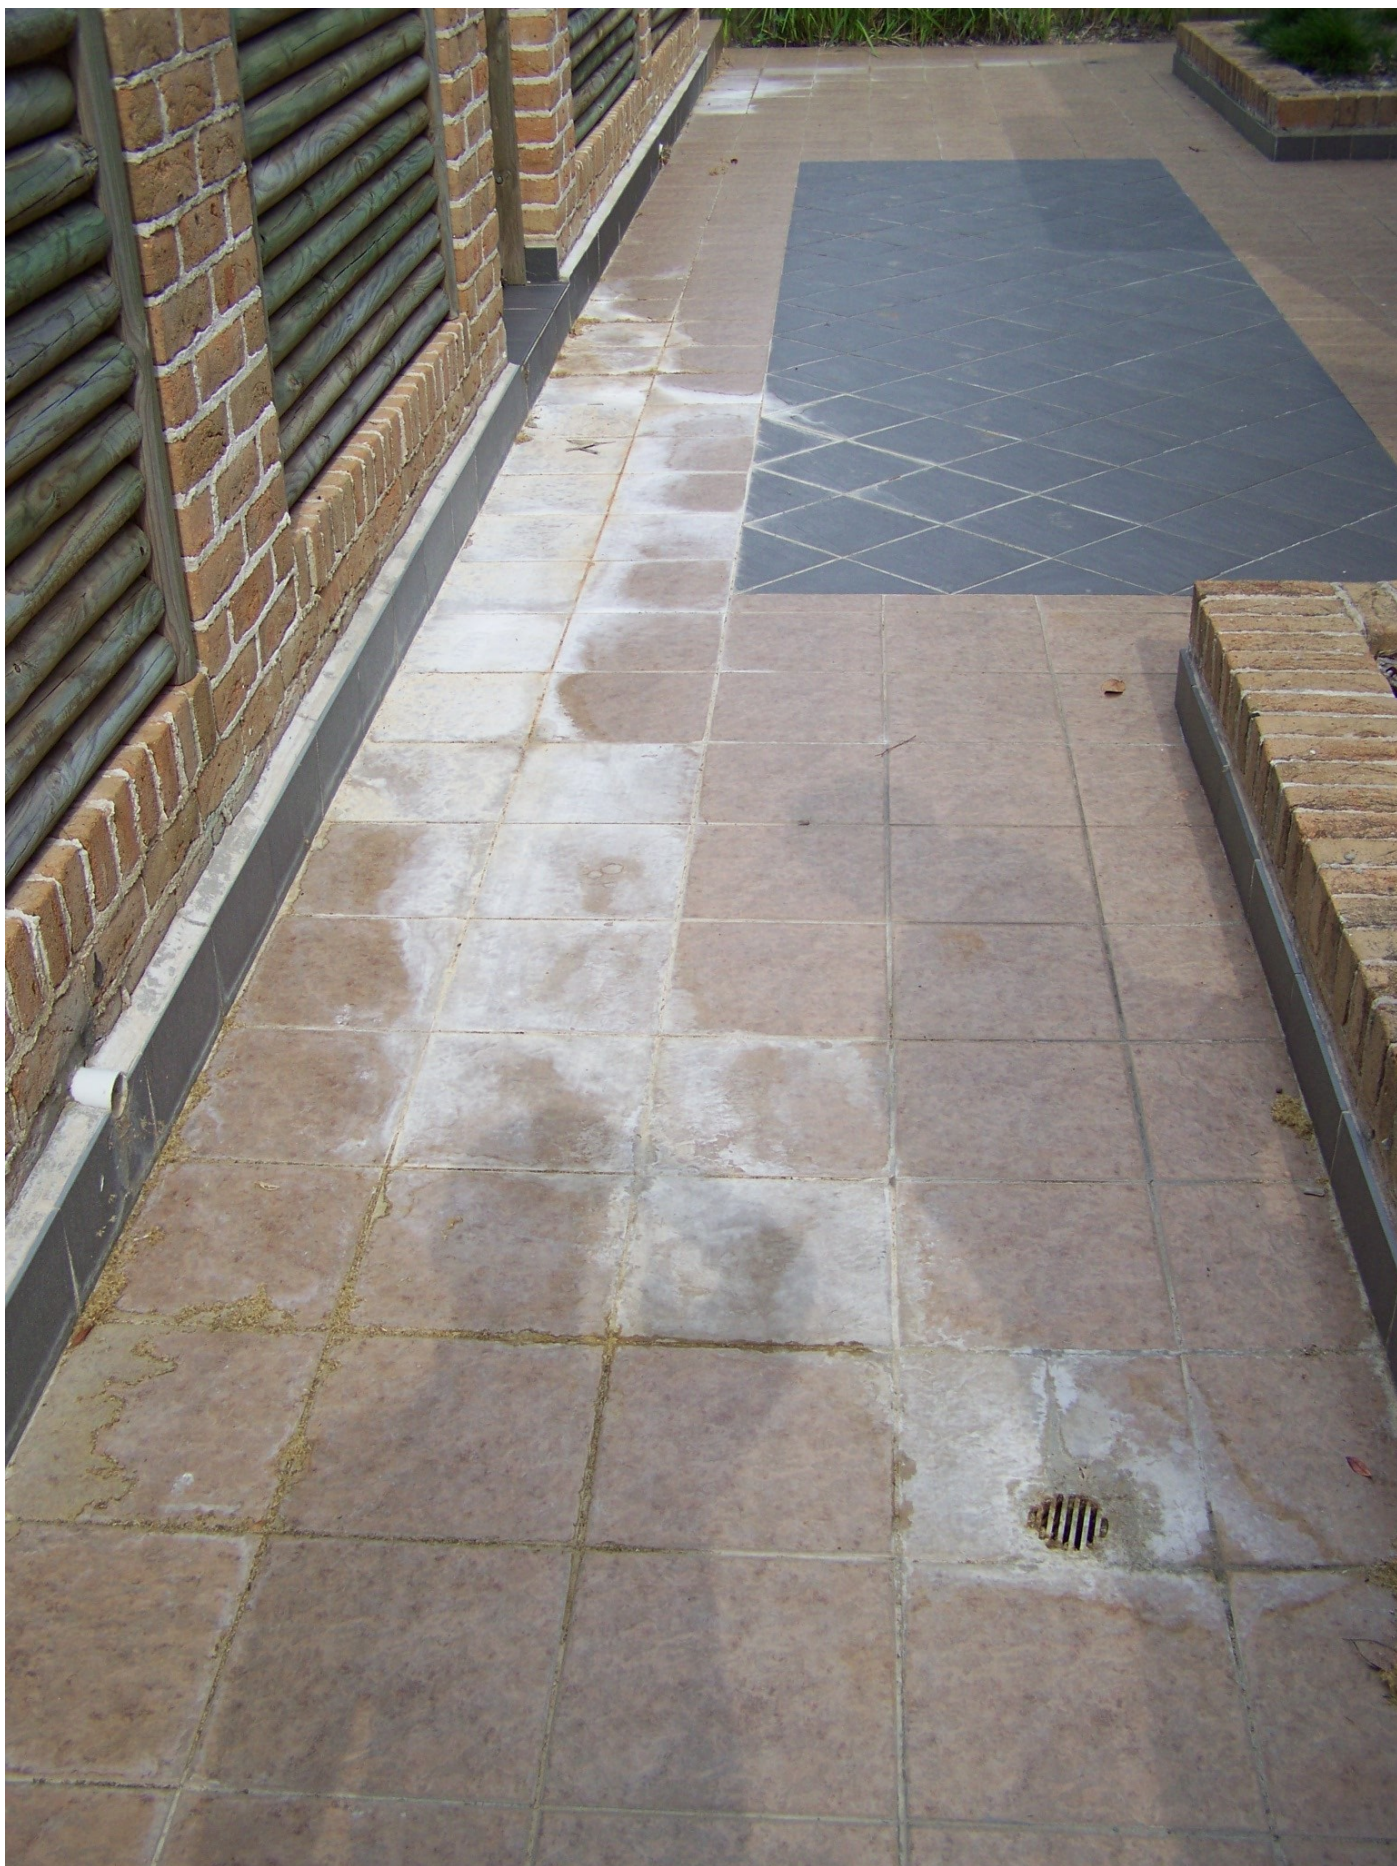
Efflorescence is generally harmless and can become less extensive over time. It is also known to become more obvious in winter but may be observed throughout the year after heavy rain and a drop in temperature. It is more a surface issue than a deeper problem.

The formation of salt deposits, usually white, on or near the surface of concrete causing a change in appearance.

There is no guaranteed solution for efflorescence but prevention can be achieved by using a few different methods: select ingredients for making the concrete or mortar with the least possible soluble salts, use tools which are clean and free of rust, salt or other harmful materials, keep water out, avoid premature drying of the concrete, treat the surface of newly finished concrete with water-repellent materials.

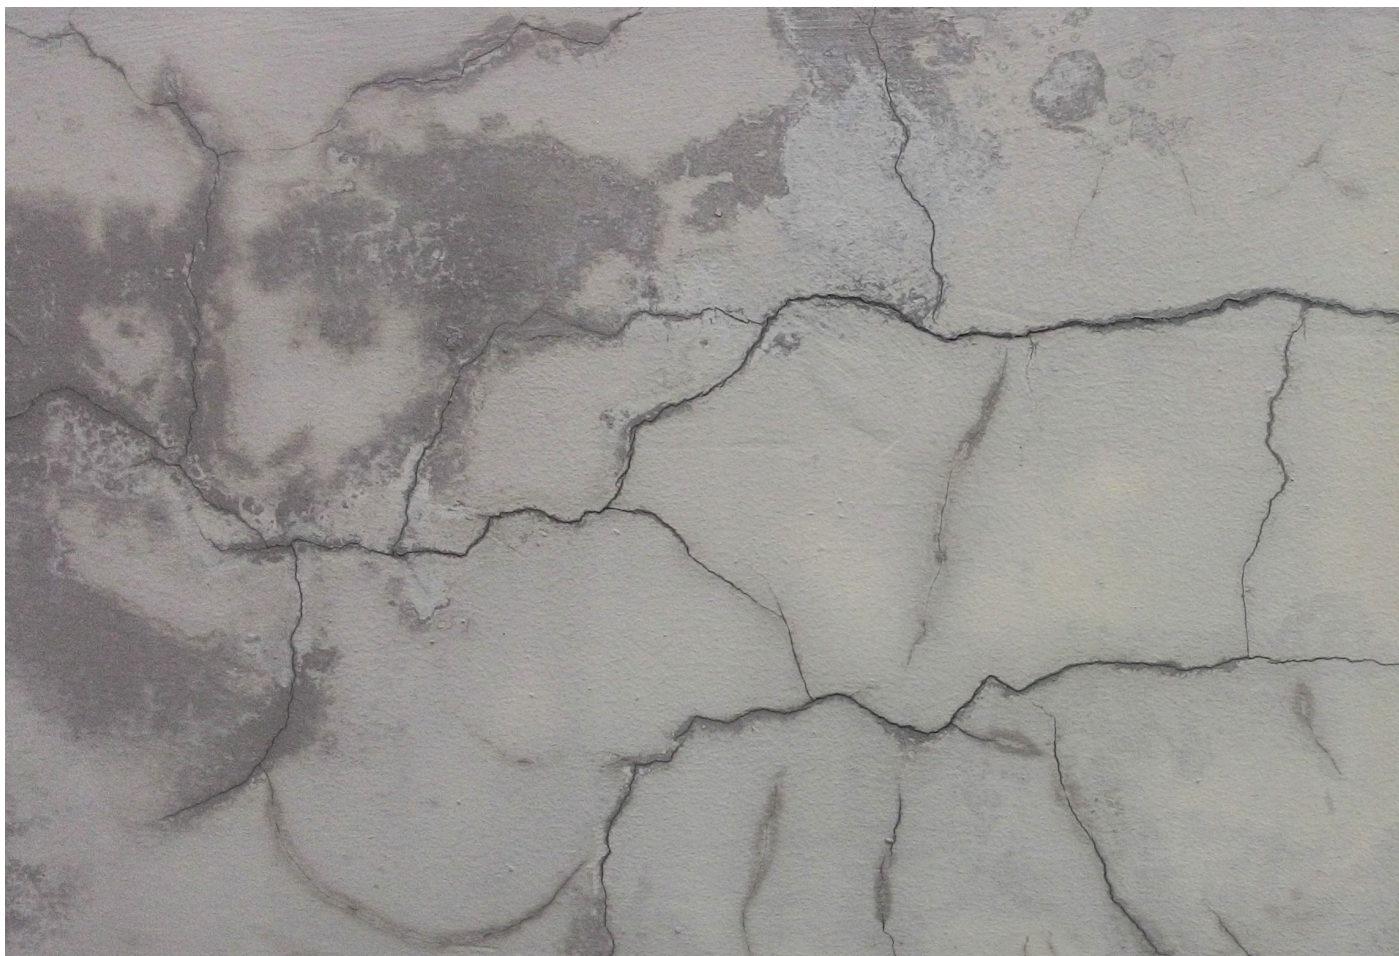
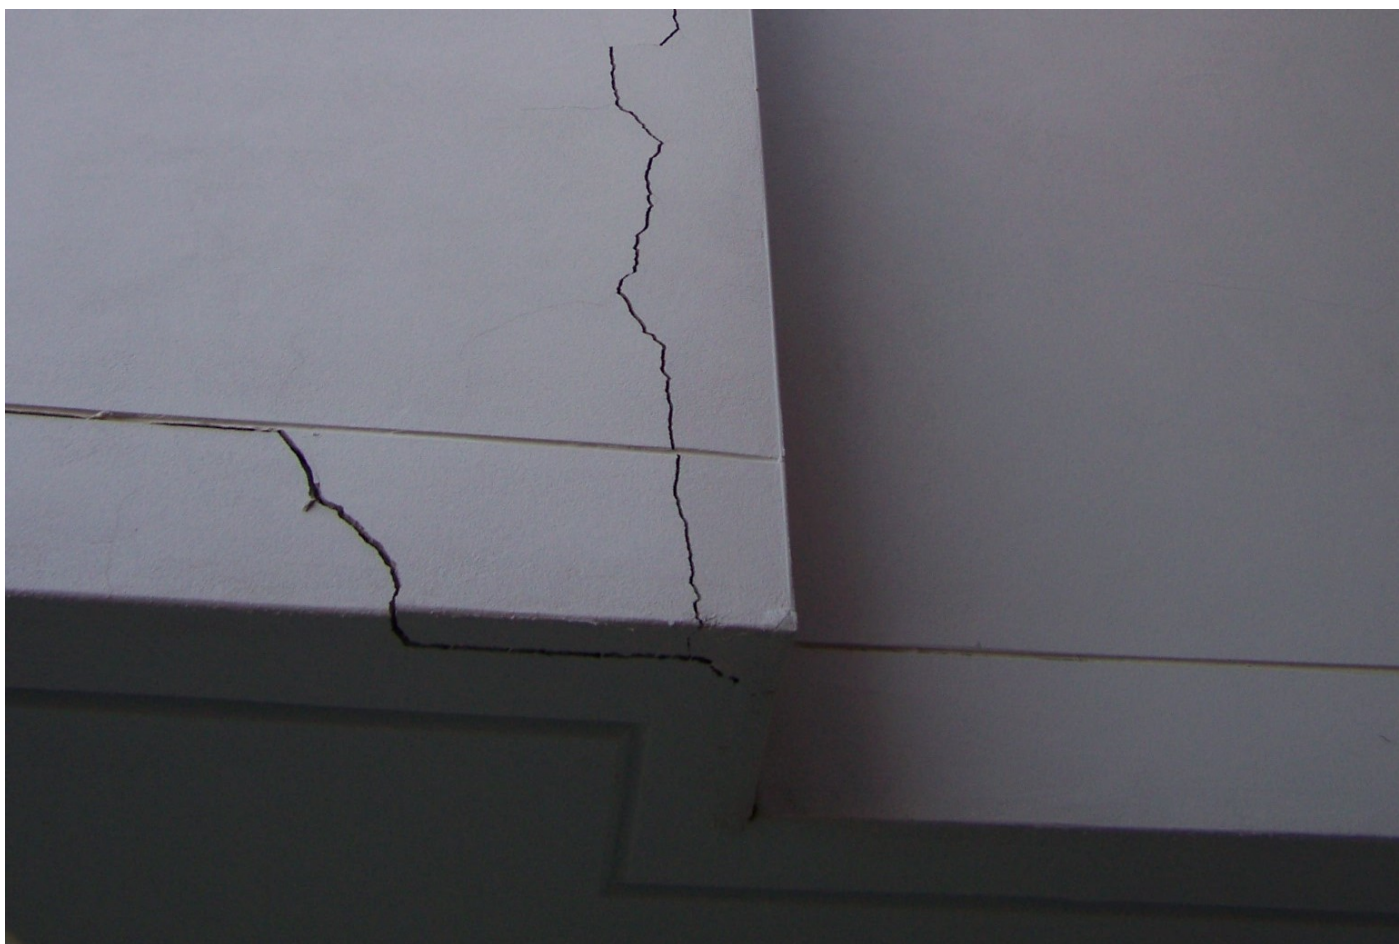
1. Cement render, no matter how it is formulated (usually a ratio including sand, lime, cement and water) is highly alkaline and extremely rigid.
2. After being mixed it is applied to the building and is then left for 28 days to cure. This allows the alkaline to stabilise before it is painted.
3. Sometimes, if the builders are concerned with money, they can use traditional decorative paints (roll on) which are low-film build and lack flexibility.
4. After being painted, the render is usually exposed to extreme variations in temperature which causes it to expand and contract. The ongoing stress on an inflexible product is what causes the render to crack. These cracks appear first as hairline cracks and become more obvious when the render is wet.

To render is to coat a surface (often brick) with plaster or cement. Due to the inflexible nature of a render, it commonly cracks due to stress.

While hairline cracking can be patched up with many different products, this does not deal with the underlying problem, it only provides a temporary solution. The recommended action (albeit the expensive one) is to demolish any affected areas and prepare and re-render them. As soon as there are cracks in any render this allows water penetration which will worsen the issue at hand and can lead to drummy render (see p. 21).

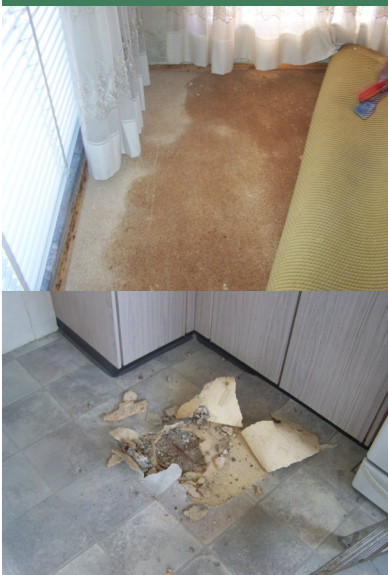
A cork-like type of flooring material which is light brown, porous, and associated with water-damage issues.

Magnesite flooring was commonly used as a finishing surface on concrete floor slabs in the 1960s and 70s, and in some buildings before and after this time, to make the concrete level and provide insulation. It also provided quite a soft finishing for the flooring. It is composed of calcined magnesite, magnesium chloride, sawdust, ground quartz or silica, and fine powdered wood waste. Because it is very porous and readily absorbs water it is associated with water-damage problems. These include:

- ⇒ The magnesite flooring can become soggy and rot away in damp patches because it retains the water it absorbs; in extreme cases the floor can noticeably lift.
- ⇒ If damp, it lets the water seep easily into the concrete slab below which can cause concrete spalling (or concrete cancer, see p. 19).
- ⇒ If damp, it can make the chlorides contained in the topping leach into the concrete slab below which also encourages and speeds up the concrete spalling process.

To prevent the above, regular airing and sunlight on the floor is very important. However, most water-damage issues are unavoidable, especially in bathrooms and kitchens (even if you get your carpet steam-cleaned the magnesite flooring will absorb the water), and most remedial works suggest it be removed. It has generally stopped being used in contemporary building construction.
